Debris/Ice/TPS Assessment and Integrated Photographic Analysis of Shuttle Mission STS-70

Gregory N. Katnik, Barry C. Bowen, J. Bradley Davis

13 July 1995

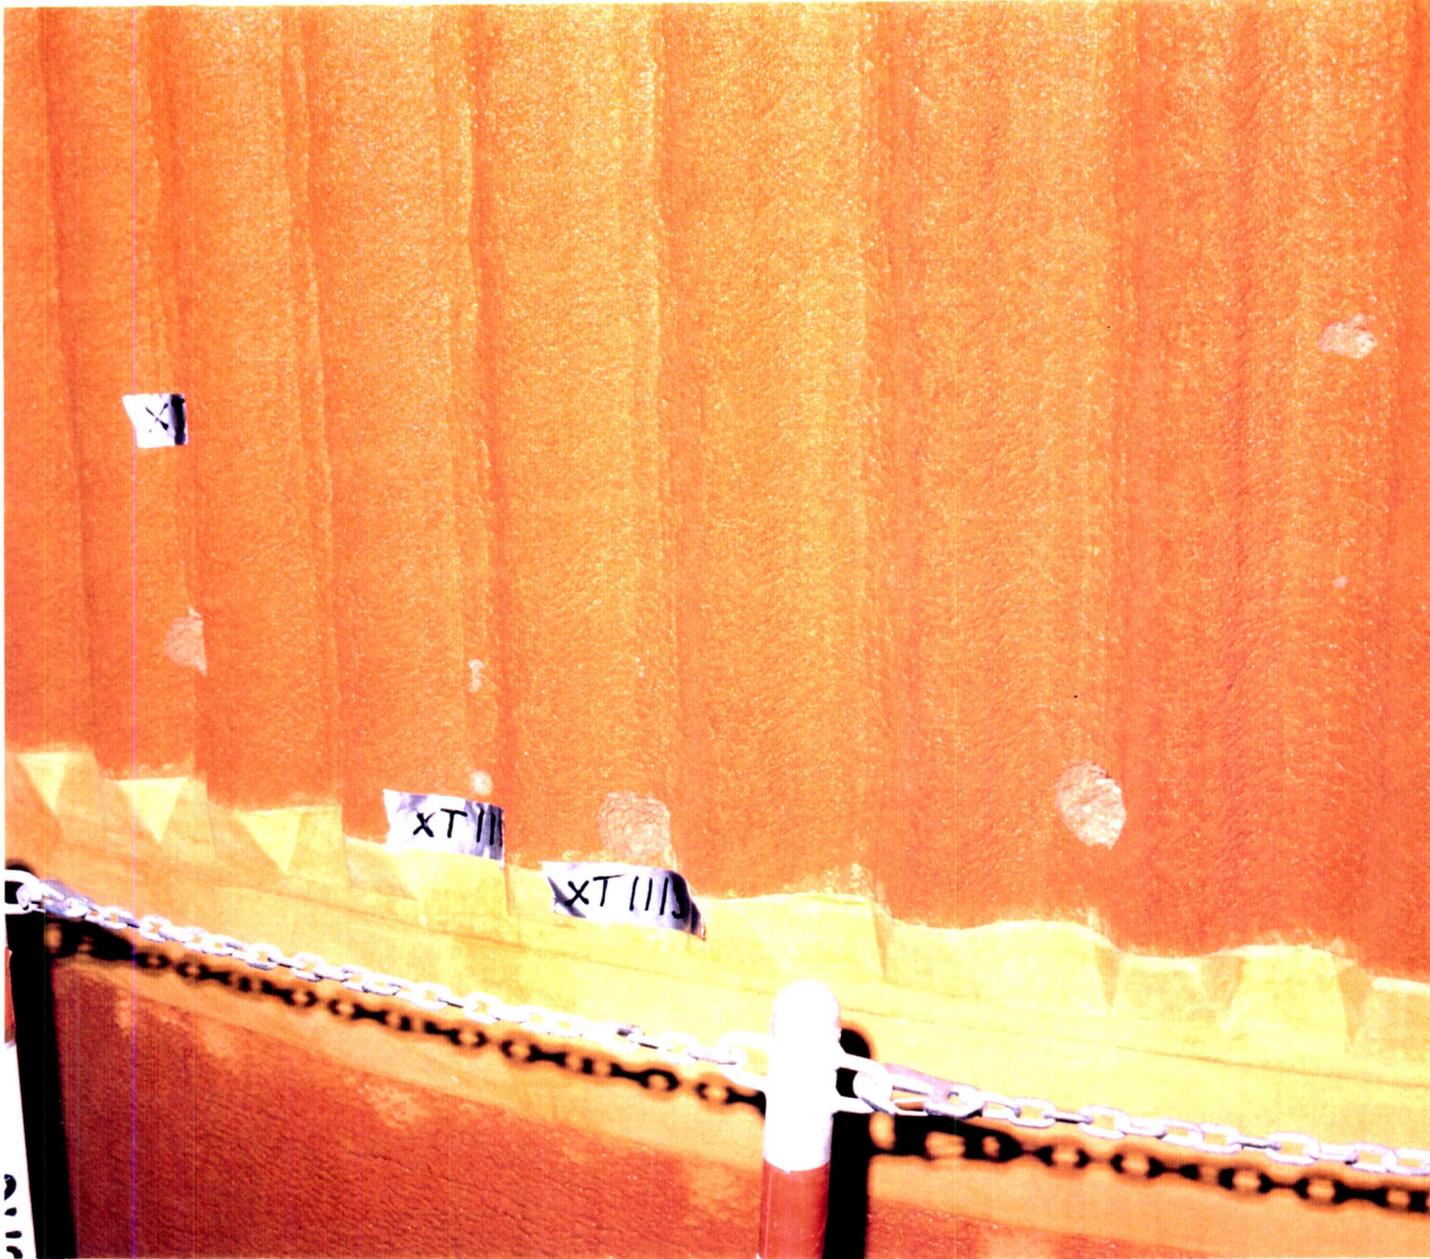
Photo 2 : Woodpecker Damage to Intertank TPS

Cavities, as large as 2 to 3 inches in diameter, had been pecked in the ET TPS by Northern Flicker woodpeckers

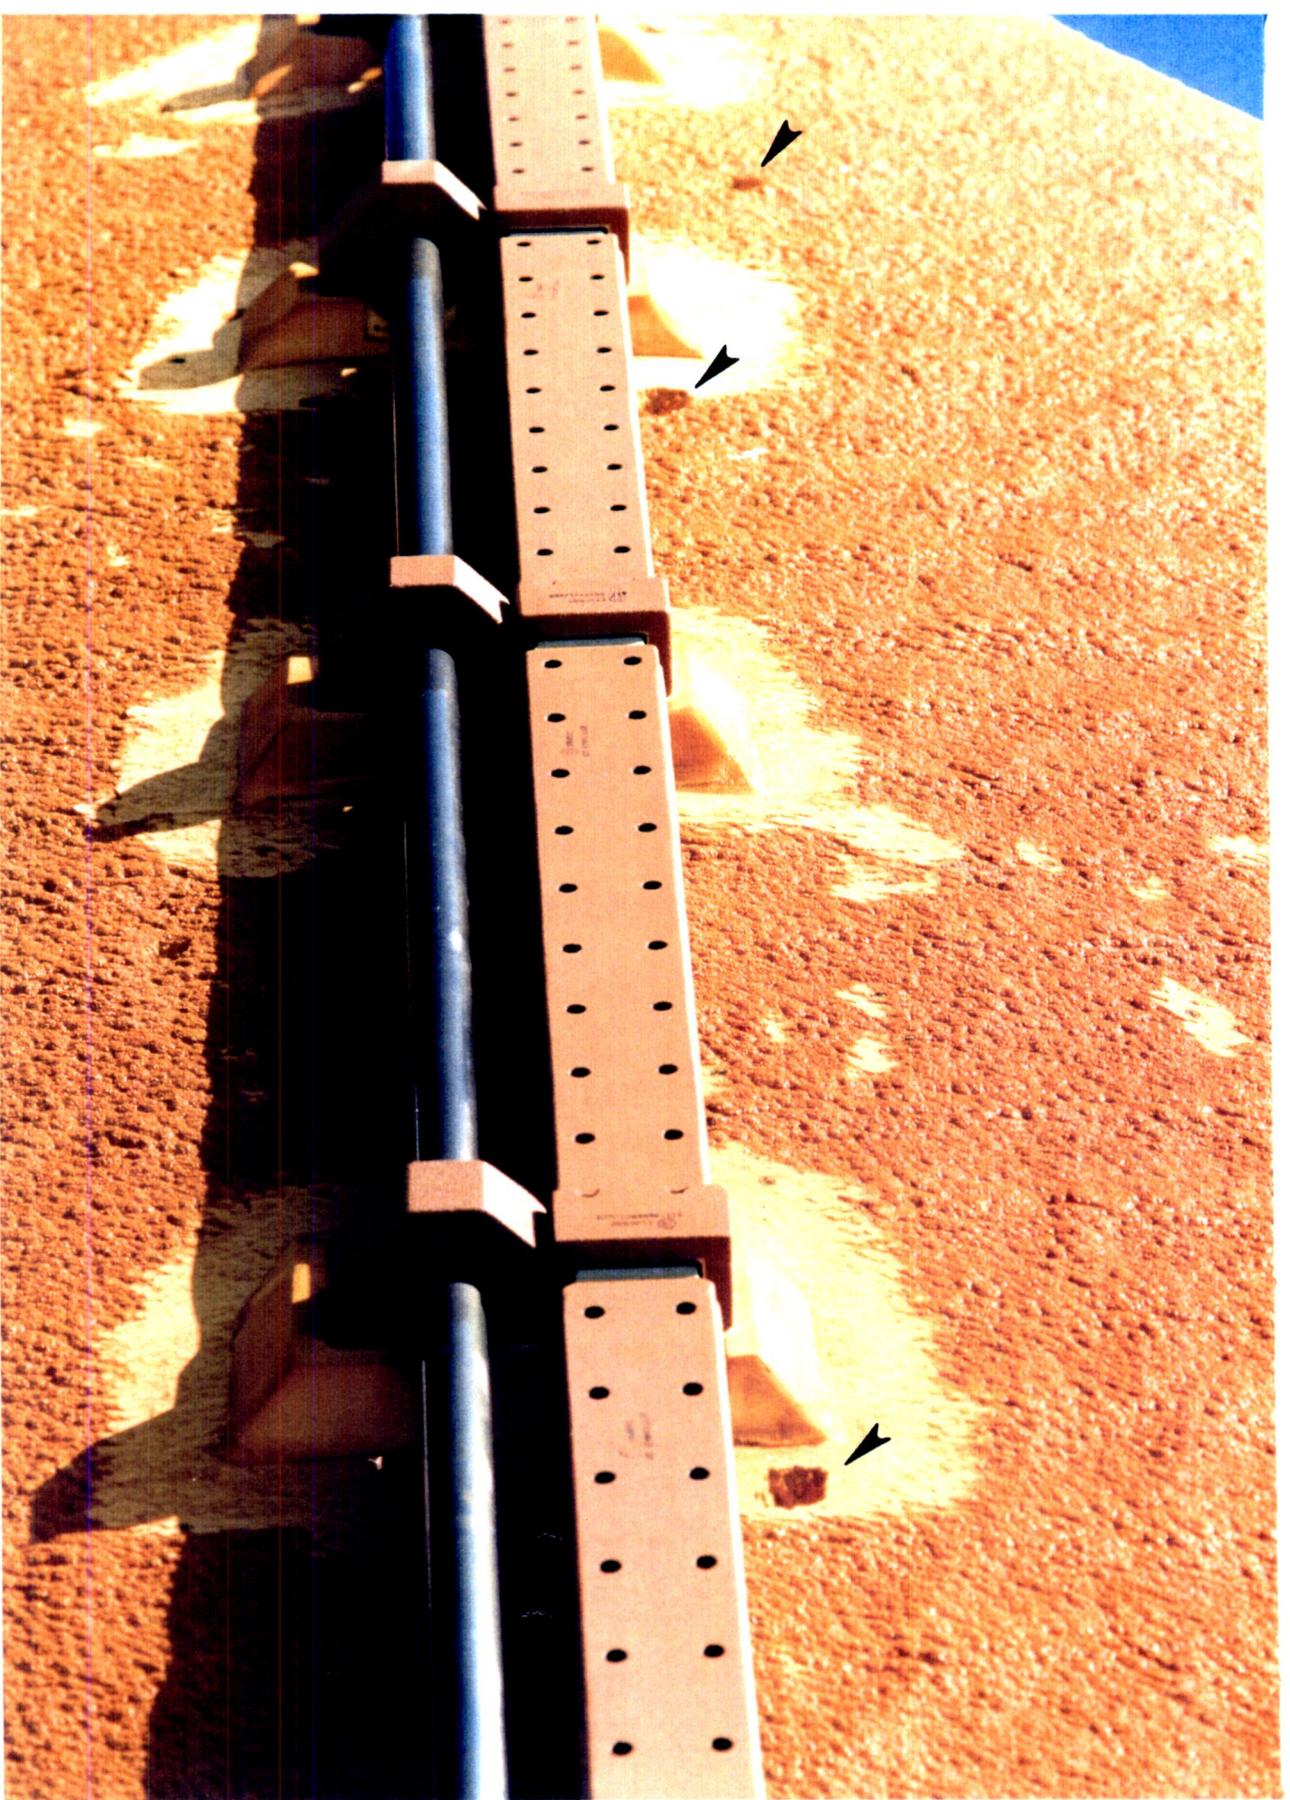
Photo 3 : Woodpecker Damage to LO2 Tank TPS

Woodpecker damage sites on the LO2 tank +Z side were located predominantly along the cable tray/pressurization line. The holes were repaired in the VAB.

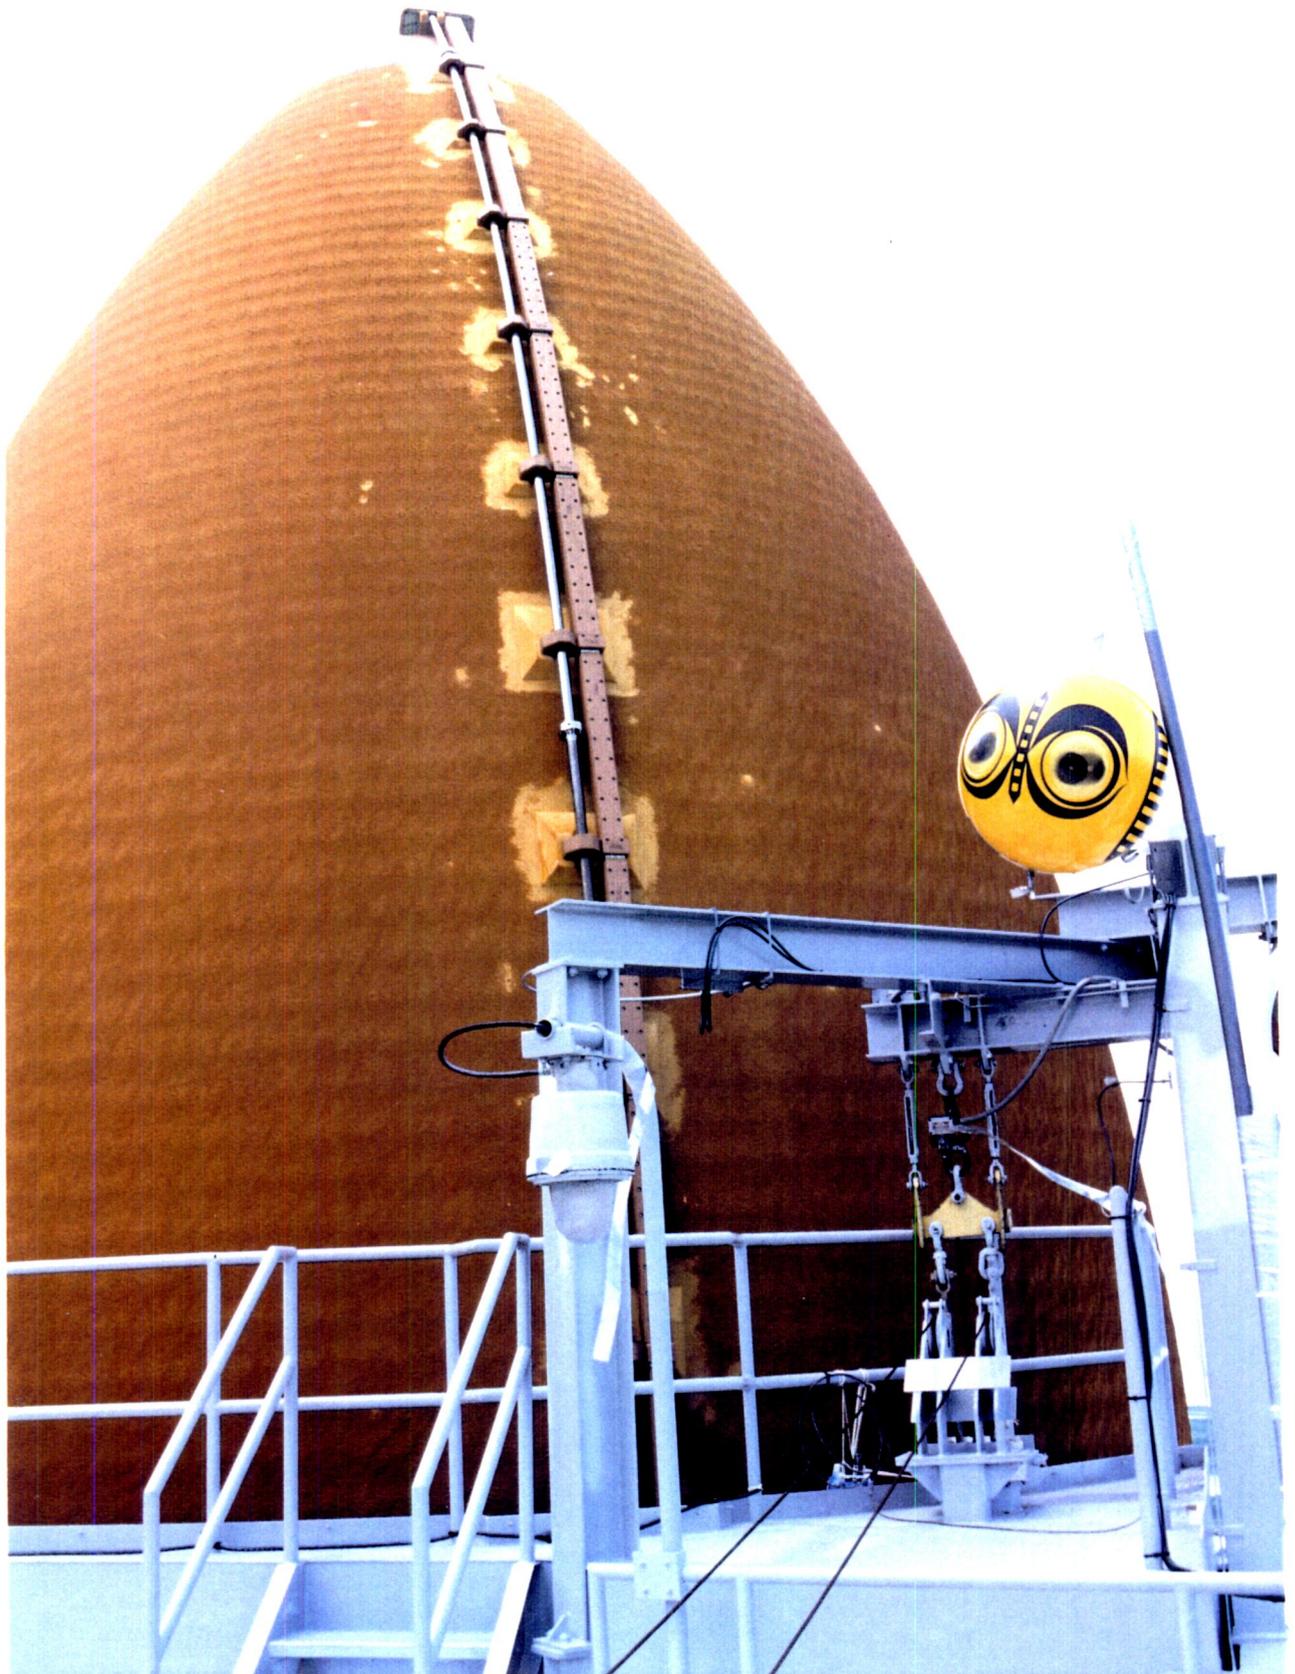
Photo 4 : TPS Repairs on the External Tank

More than 170 woodpecker holes were repaired on the External Tank
Note yellow balloon with predator eyes installed on the facility as a woodpecker deterrent

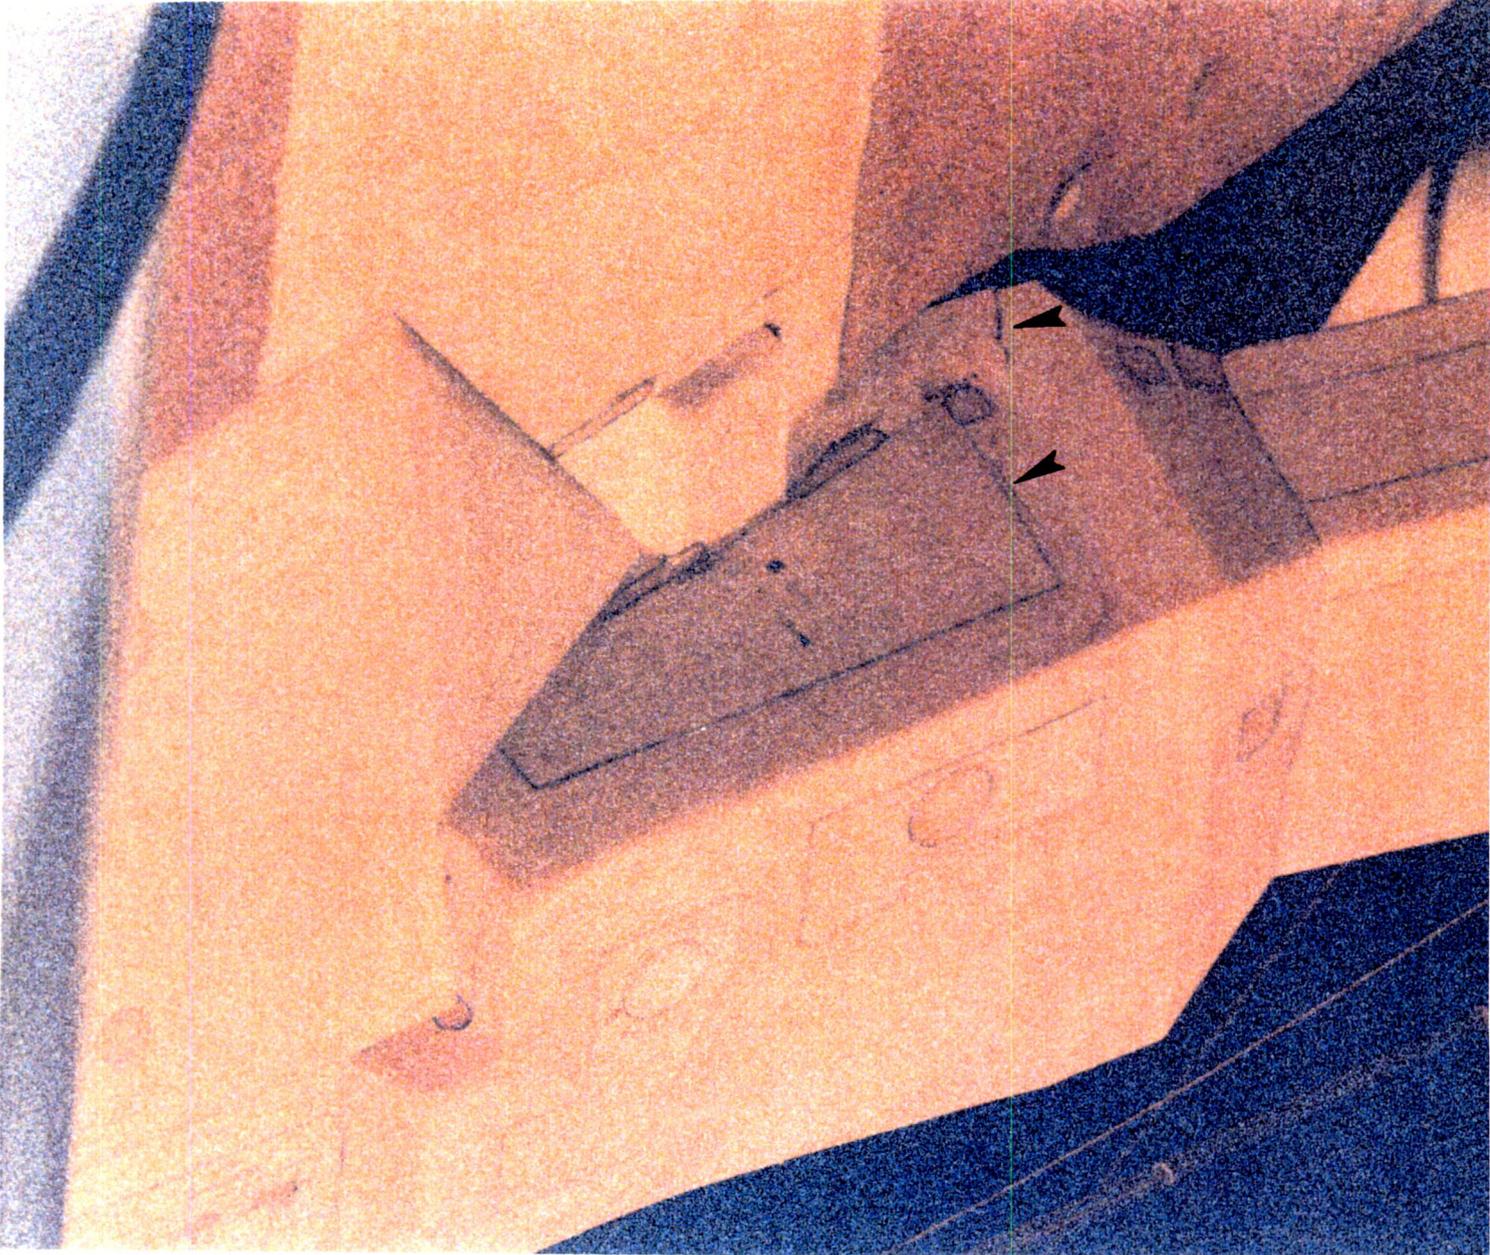
Photo 5 : Two-Crack Condition on -Y ET/SRB Cable Tray

There were no anomalies on the redesigned bipod jack pad closeouts. Two cracks, 4-inches long by 1/4-inch wide and 5-inches long by 1/8-inch wide, were present in the -Y ET/SRB cable tray forward surface TPS. The two-crack condition was assessed from a debris and ascent thermal environment standpoint and was found acceptable for flight per the NSTS-08303 criteria.

The condition was assessed by the Ice/Debris Team and found acceptable for flight

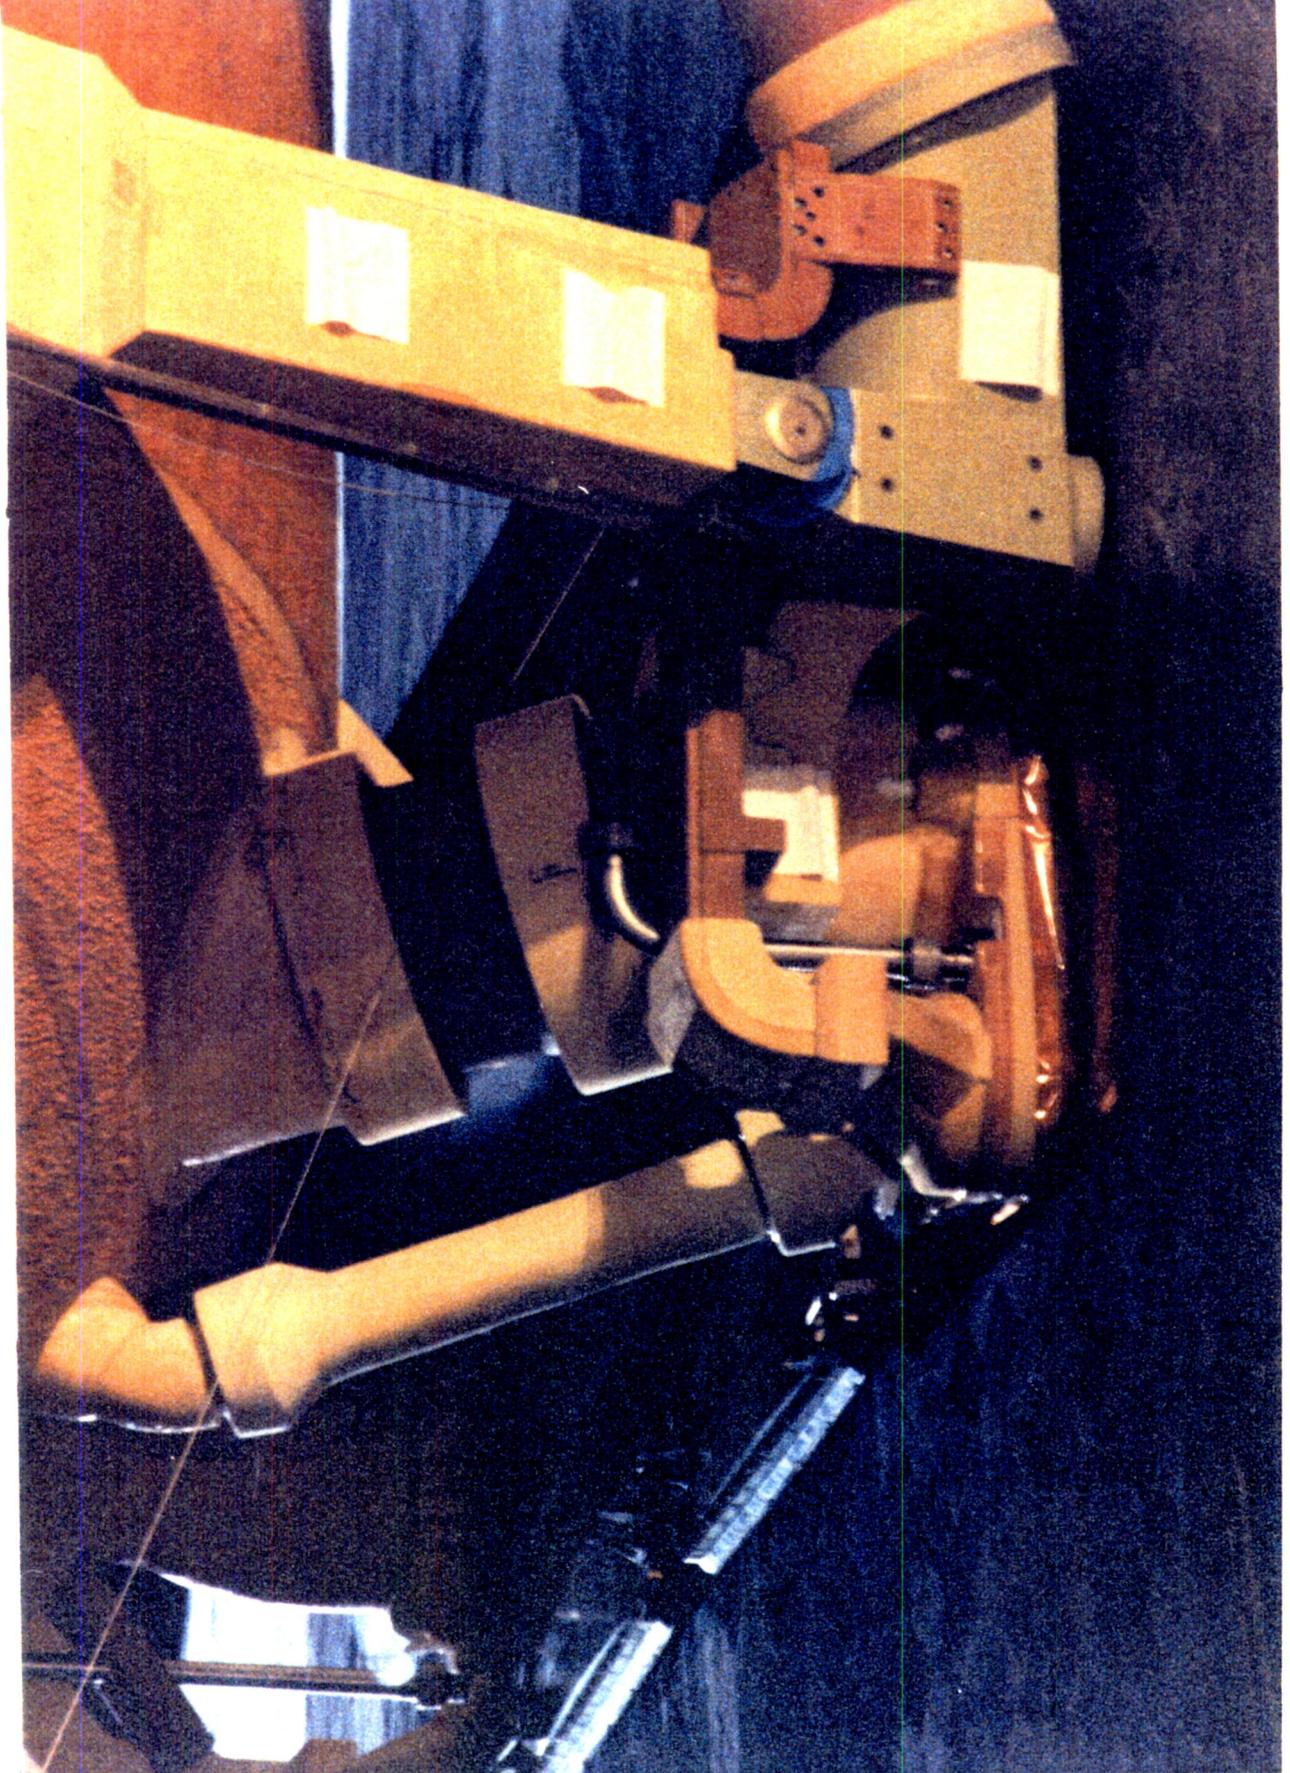
Photo 6 : LH2 ET/ORB Umbilical

Less than usual amounts of ice/frost had accumulated on the LH2 ET/ORB umbilical purge barrier top and outboard sides. Typical ice/frost fingers were present on the pyro canister and plate gap purge vents. Ice/frost had formed on the aft pyro canister closeout bondline. No unusual vapors or cryogenic drips had appeared during tanking, stable replenish, and launch.

Ice/frost accumulations on the umbilical were less than usual

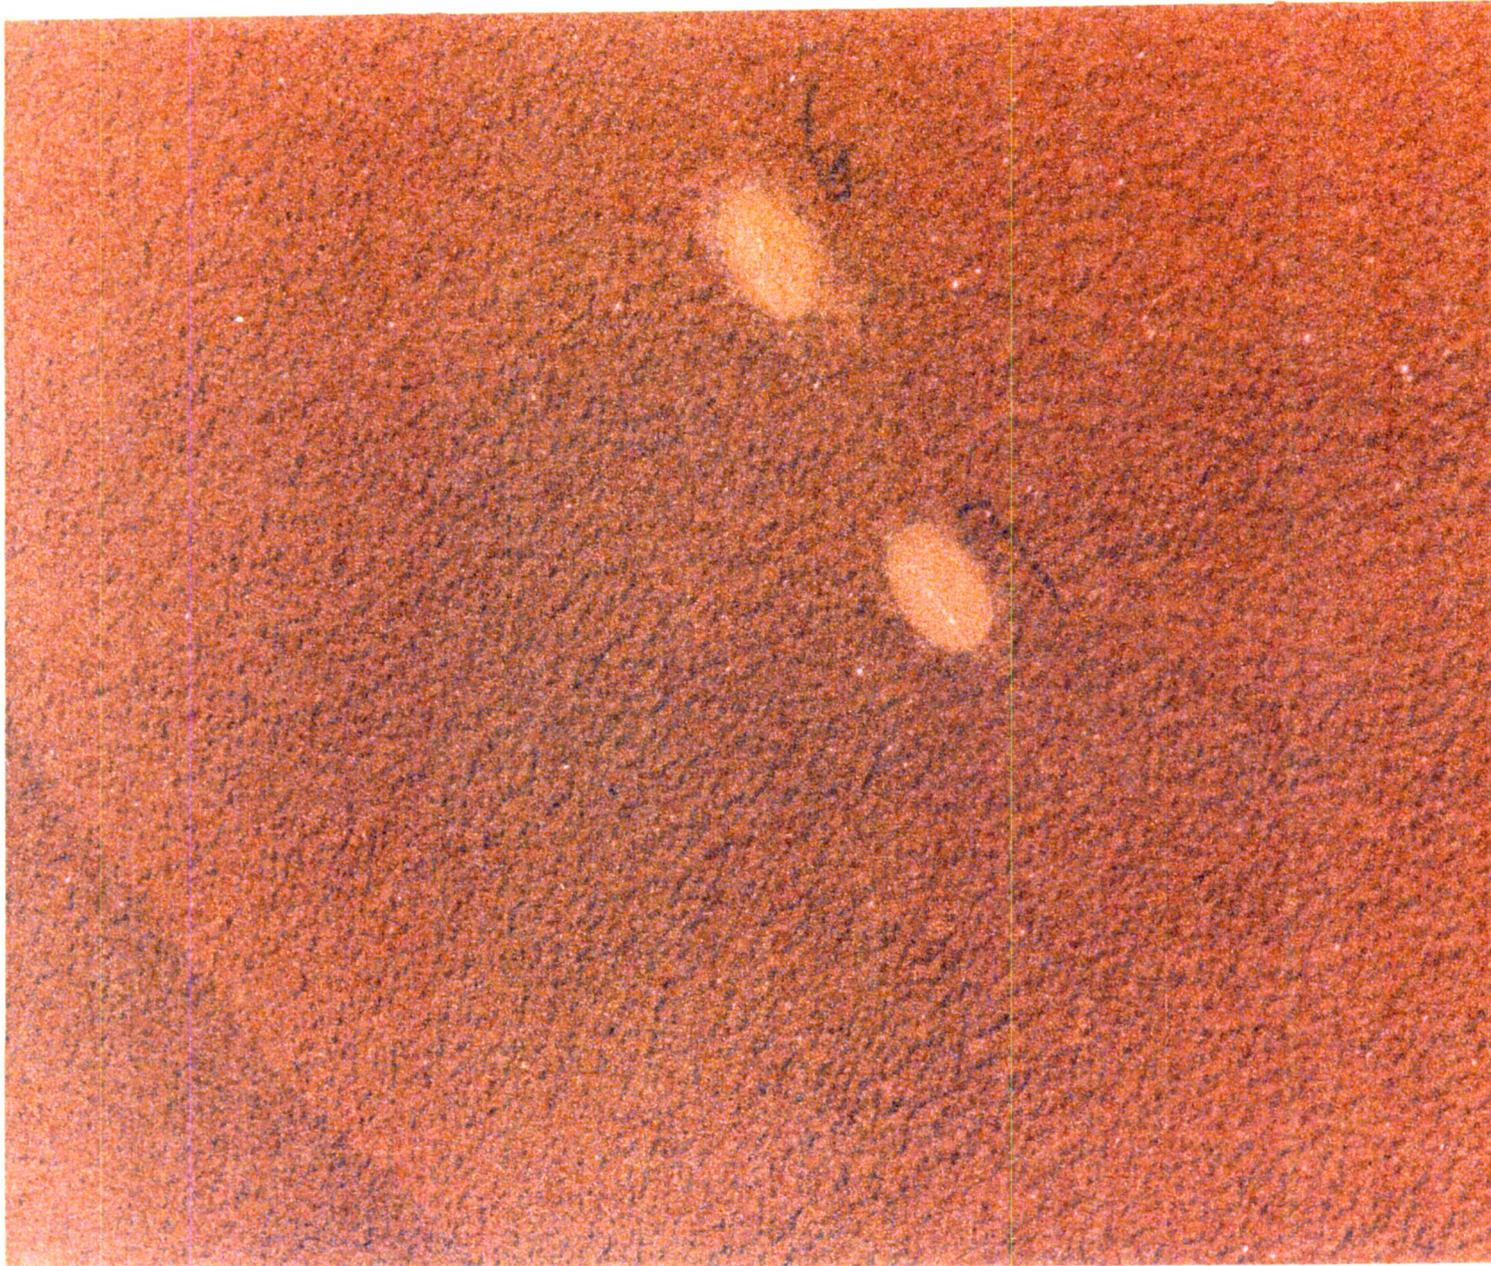
Photo 7 : Woodpecker Hole Repairs After Cryoload

A three-man segment of the Final Inspection Team specifically checked the woodpecker damage site repairs, none of which exhibited ice/frost formations, debonds, or material protrusions. The portable STI scanner showed no unusual or unexpected temperature gradients between the repaired areas and the adjacent acreage.

Typical PDL repairs to the woodpecker holes in the External Tank TPS
None of the repairs exhibited ice/frost formations, debonds, or material protrusions

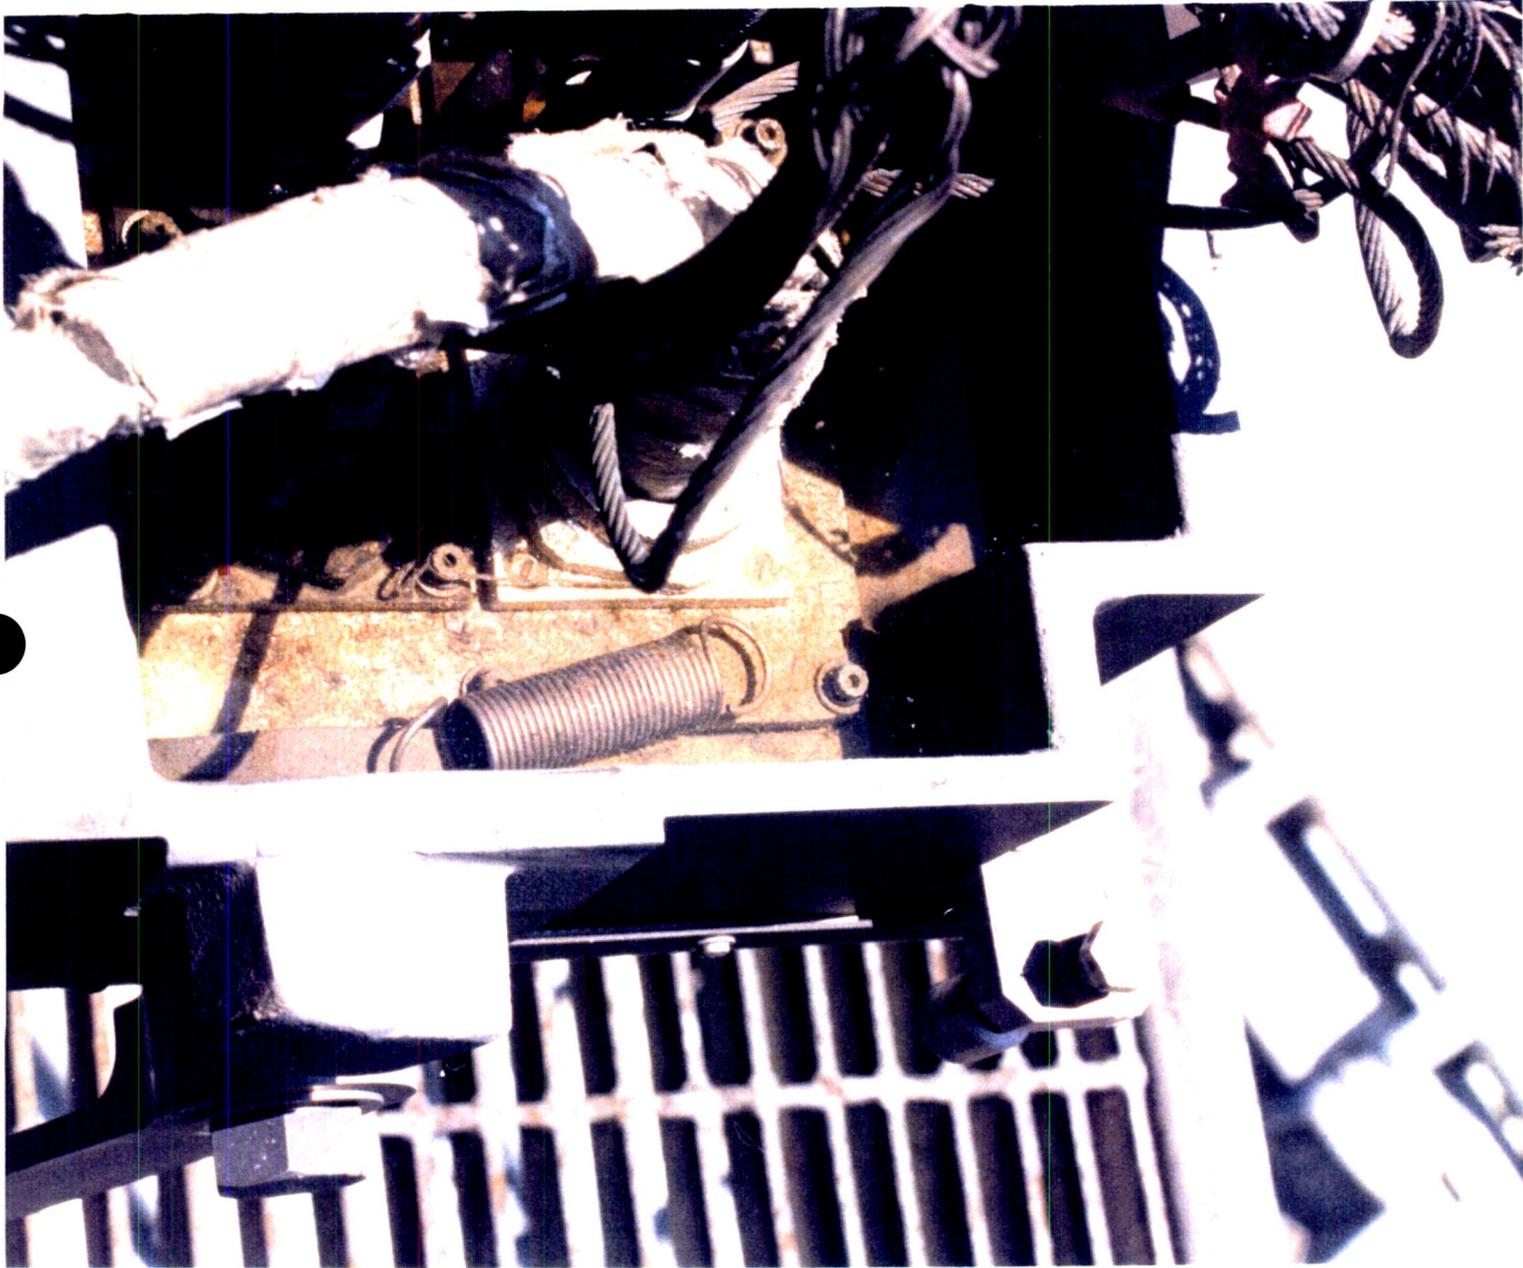
Photo 8 : Loose Spring on GUCP

A 2-inch by 3/4-inch spring, believed to be from the facility rather than the GUCP, was found laying in the ground umbilical carrier assembly near electrical connector J2

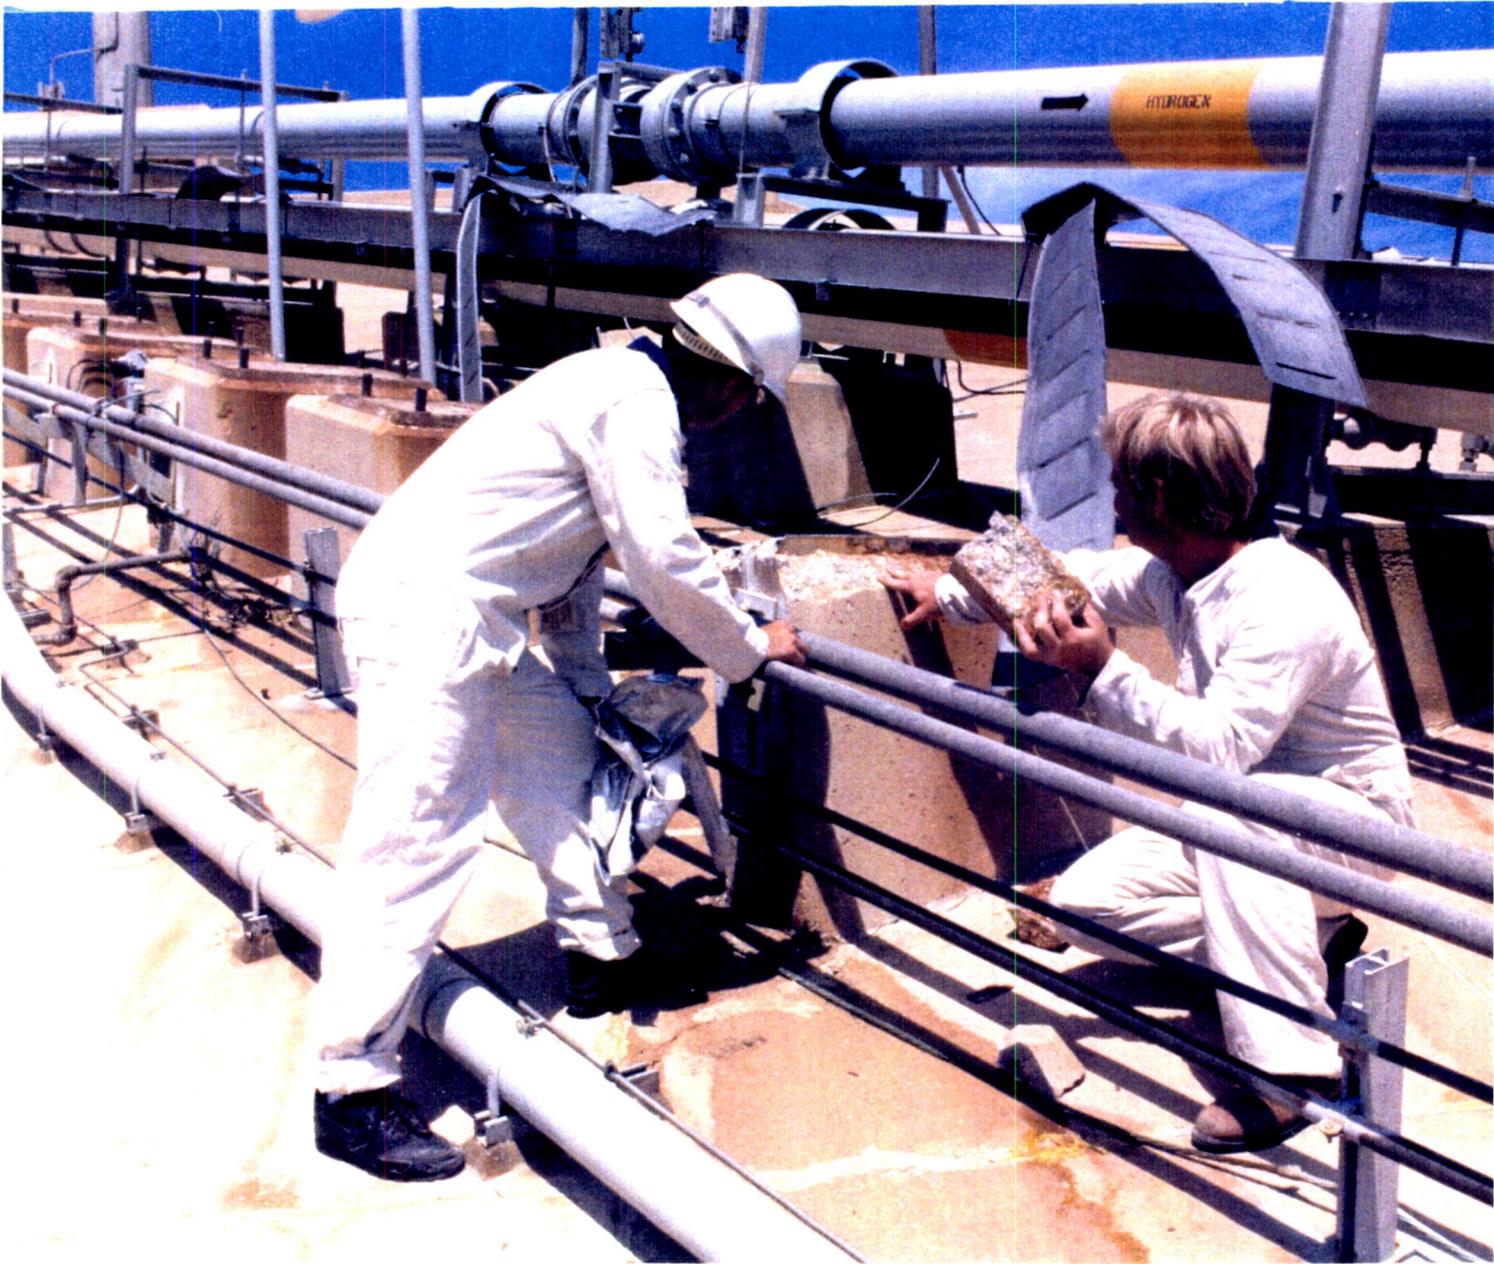
Photo 9 : Launch Pad Damage

Extensive damage occurred to the facility cable tray covers running along side the hydrogen cross country fill lines on the northeast side of the pad. Some of the concrete supports were also broken

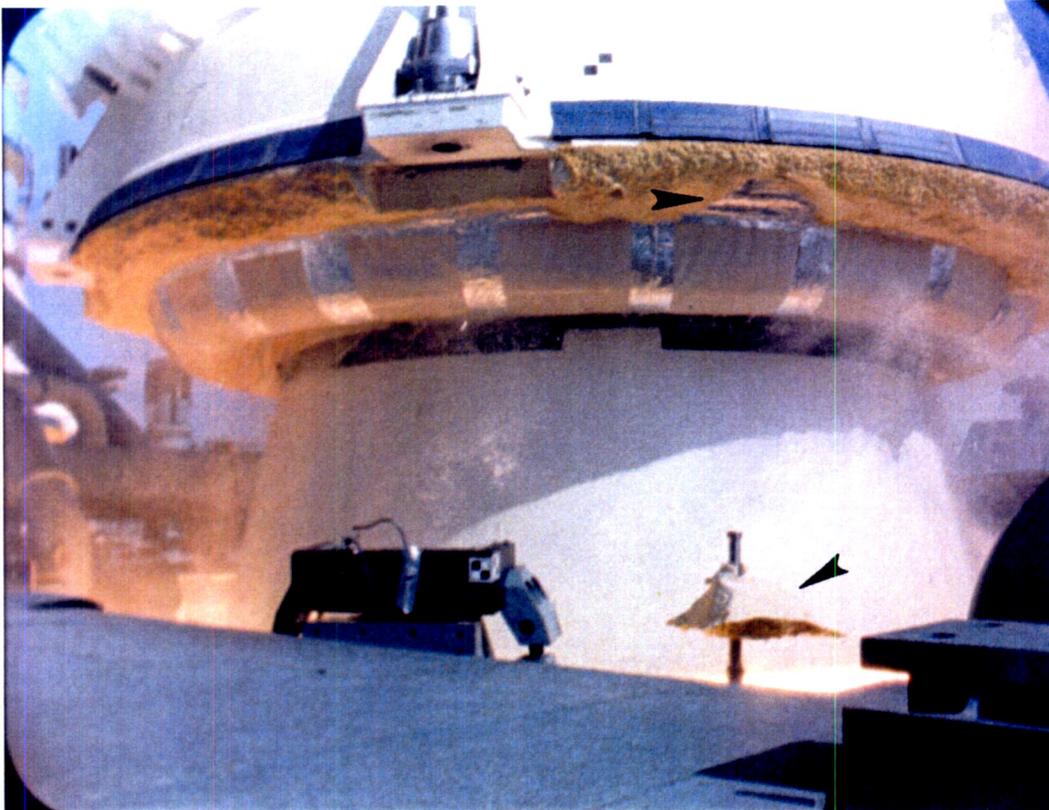
Photo 10 : Aft Skirt Instafoam Pulled Loose

A large piece of aft skirt instafoam, approximately 18 inches long by 10 inches wide by 10 inches thick, stuck to the RH SRB aft skirt purge line as the vehicle lifted off holddown post #2. Loss of this foam piece was not a safety-of-flight concern.

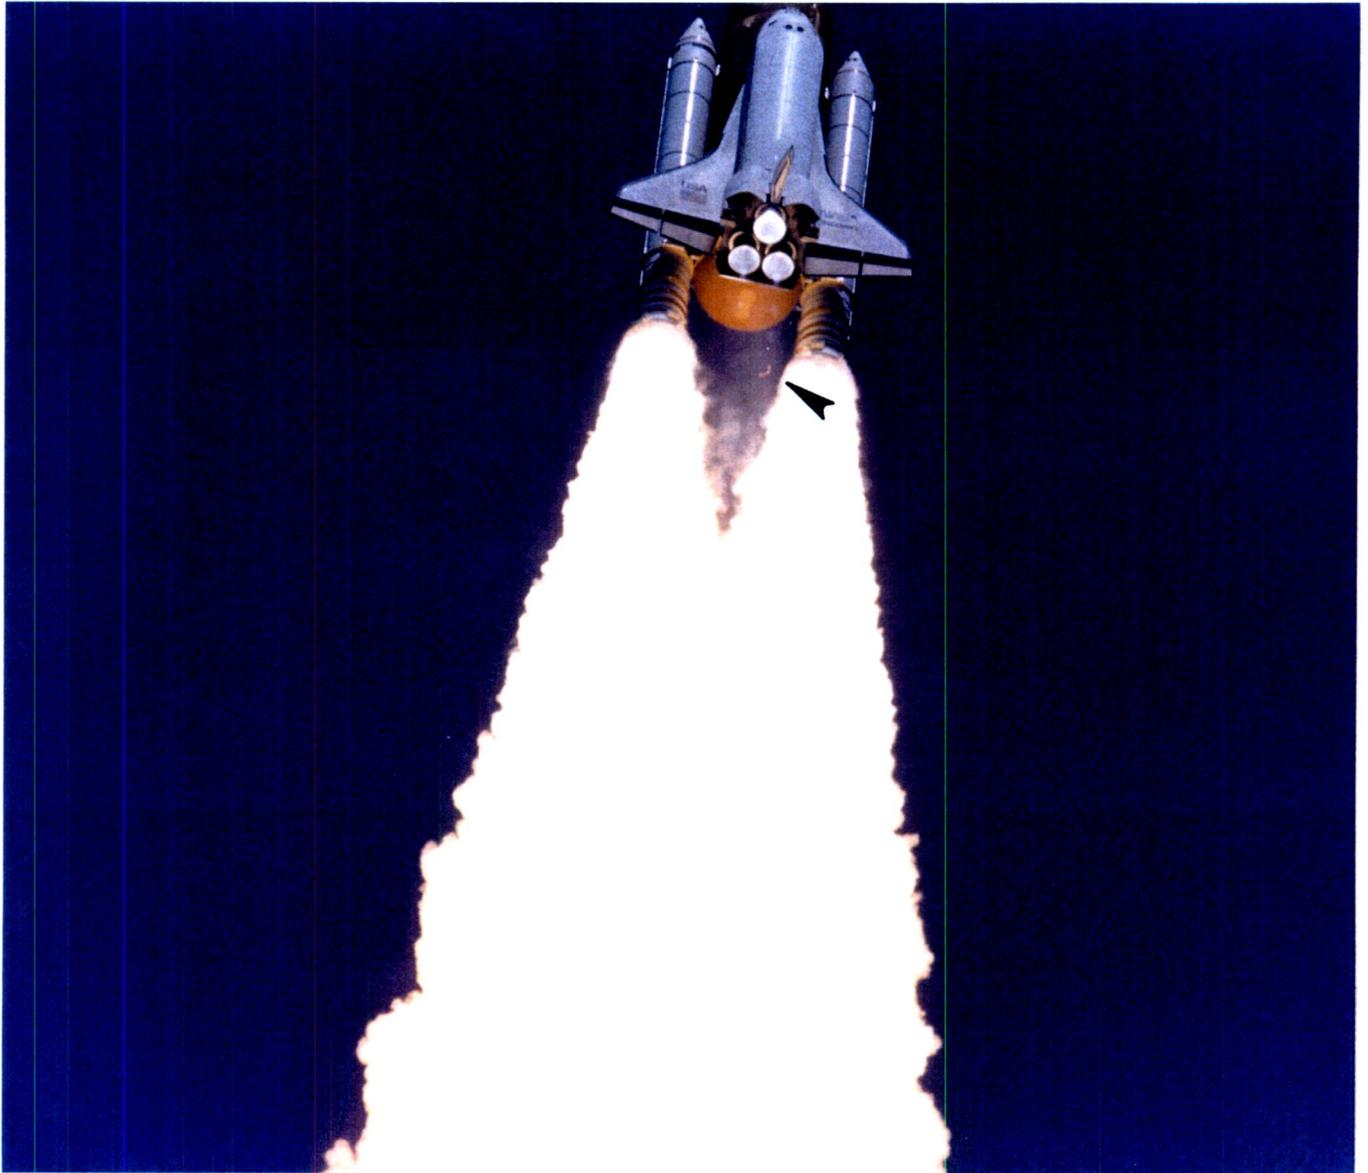
Photo 11 : Umbilical Purge Barrier Material

Several larger-than-usual pieces of LH2 and LO2 ET/ORB umbilical purge barrier baggie material fell aft past the body flap into the SRB plume at 13:42:11.800 GMT

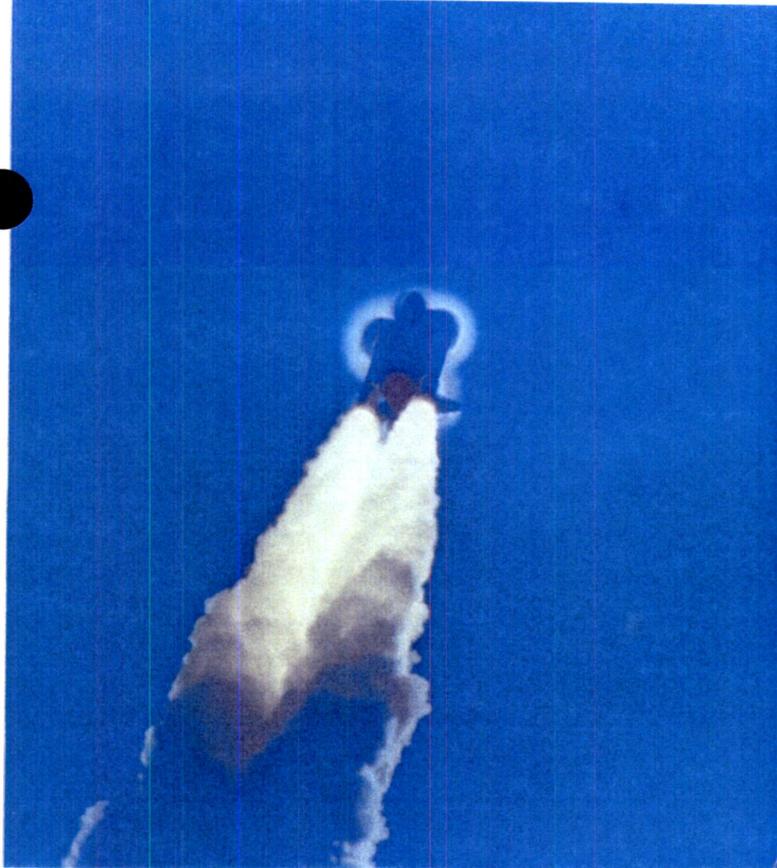
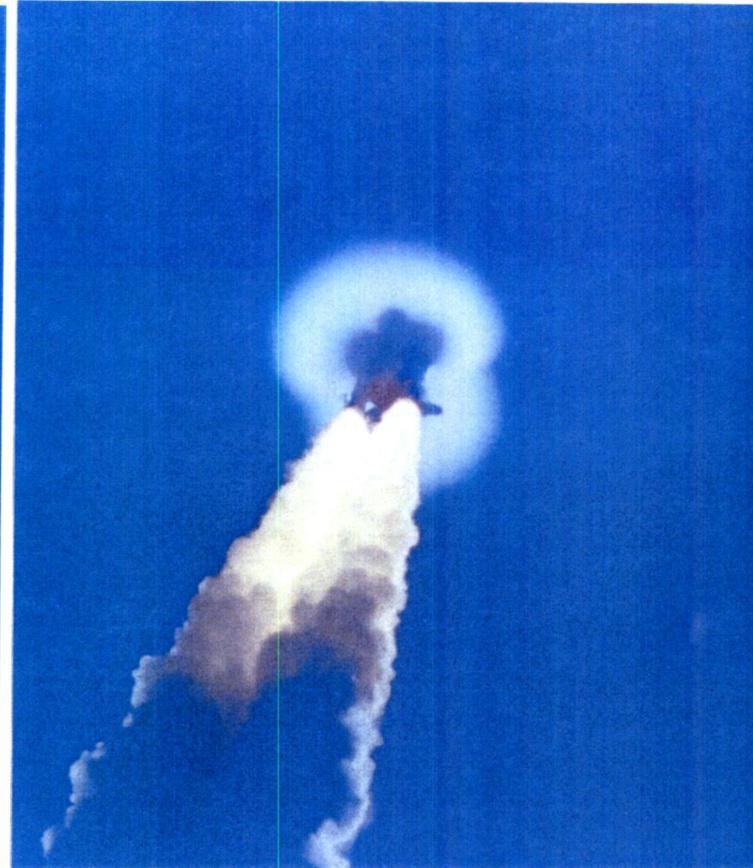
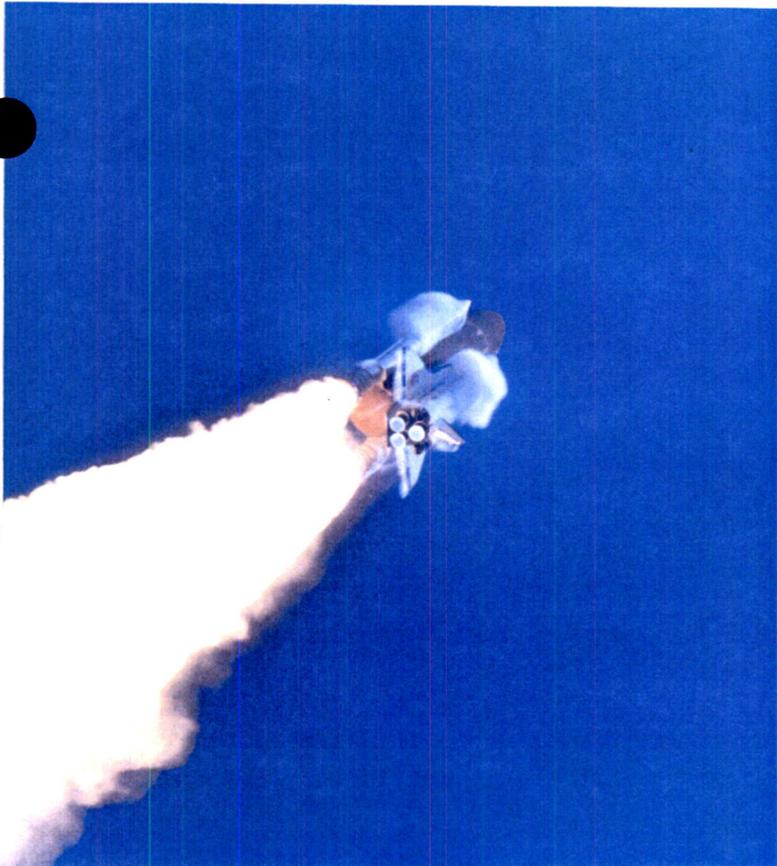
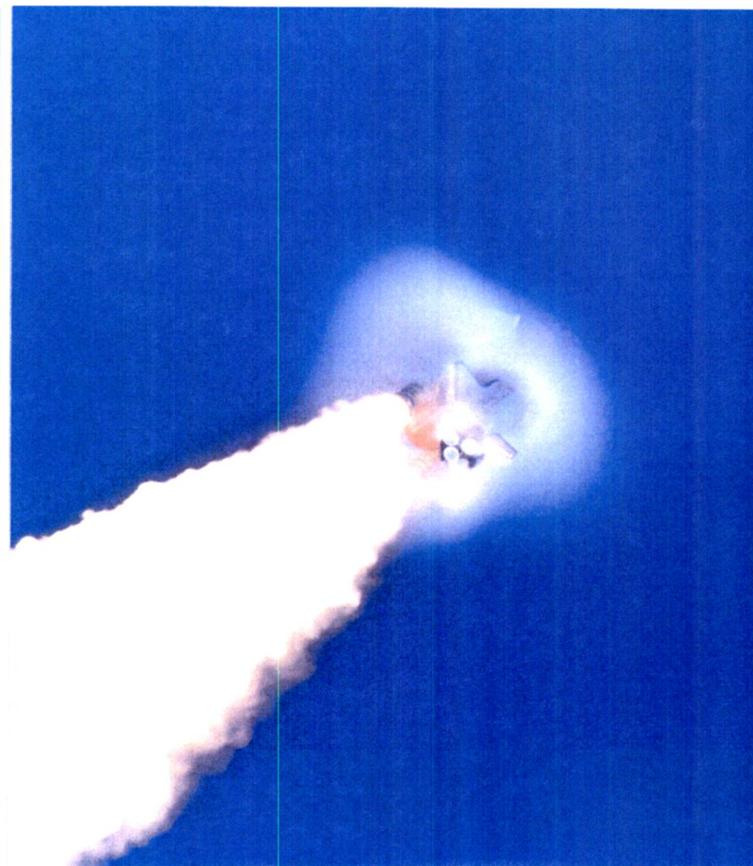
Photo 12 : Condensation Collars and Moisture Layers

Localized flow condensation collars formed on the vehicle due to supersonic shock waves and passage through atmospheric moisture layers during ascent starting at 13:42:38 GMT. This was an expected occurrence given the warm, humid ambient weather conditions at the time of launch.
